# BUILDING AIR LEAKAGE AND EFFECTS ON THE BUILDING ENVELOPE

## Tremco Roofing and Building Maintenance

Presenter Name Steven Tratt

Date June 14<sup>th</sup> 2018

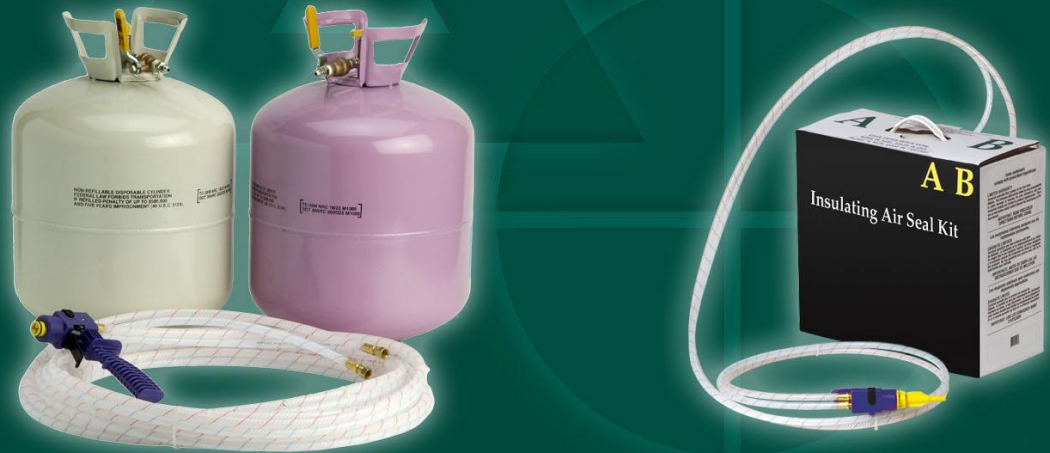
### 2-component polyurethane foam insulating air seal kits

Must meet requirement of ULC Standard S711.1

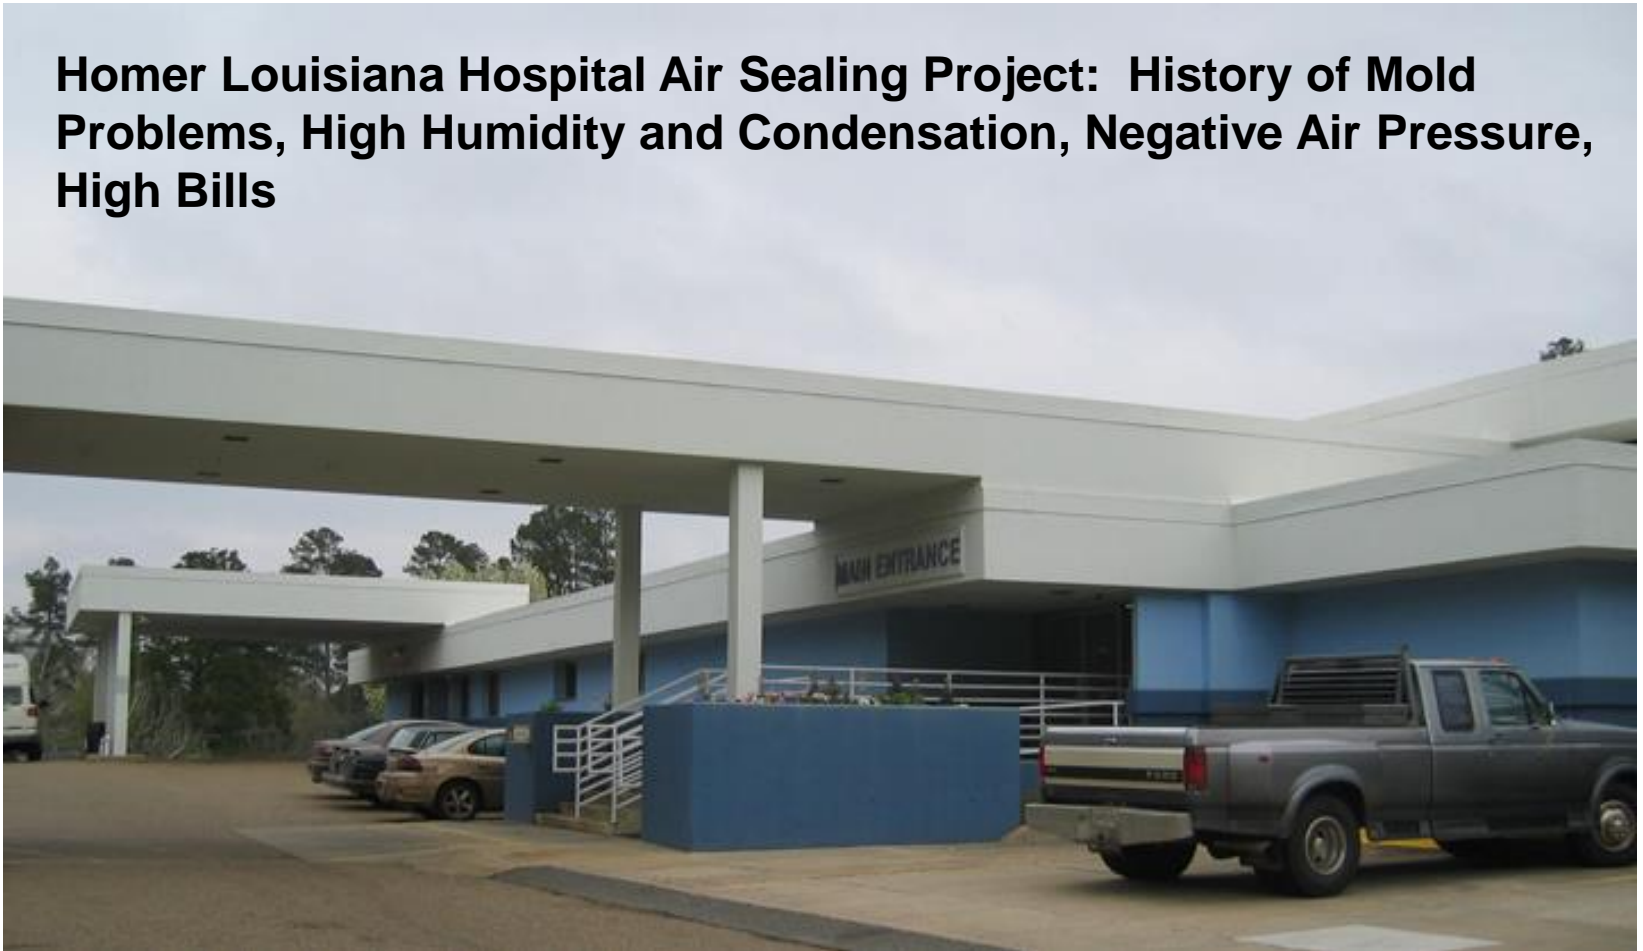
**Homer Louisiana Hospital Air Sealing Project: History of Mold Problems, High Humidity and Condensation, Negative Air Pressure, High Bills**

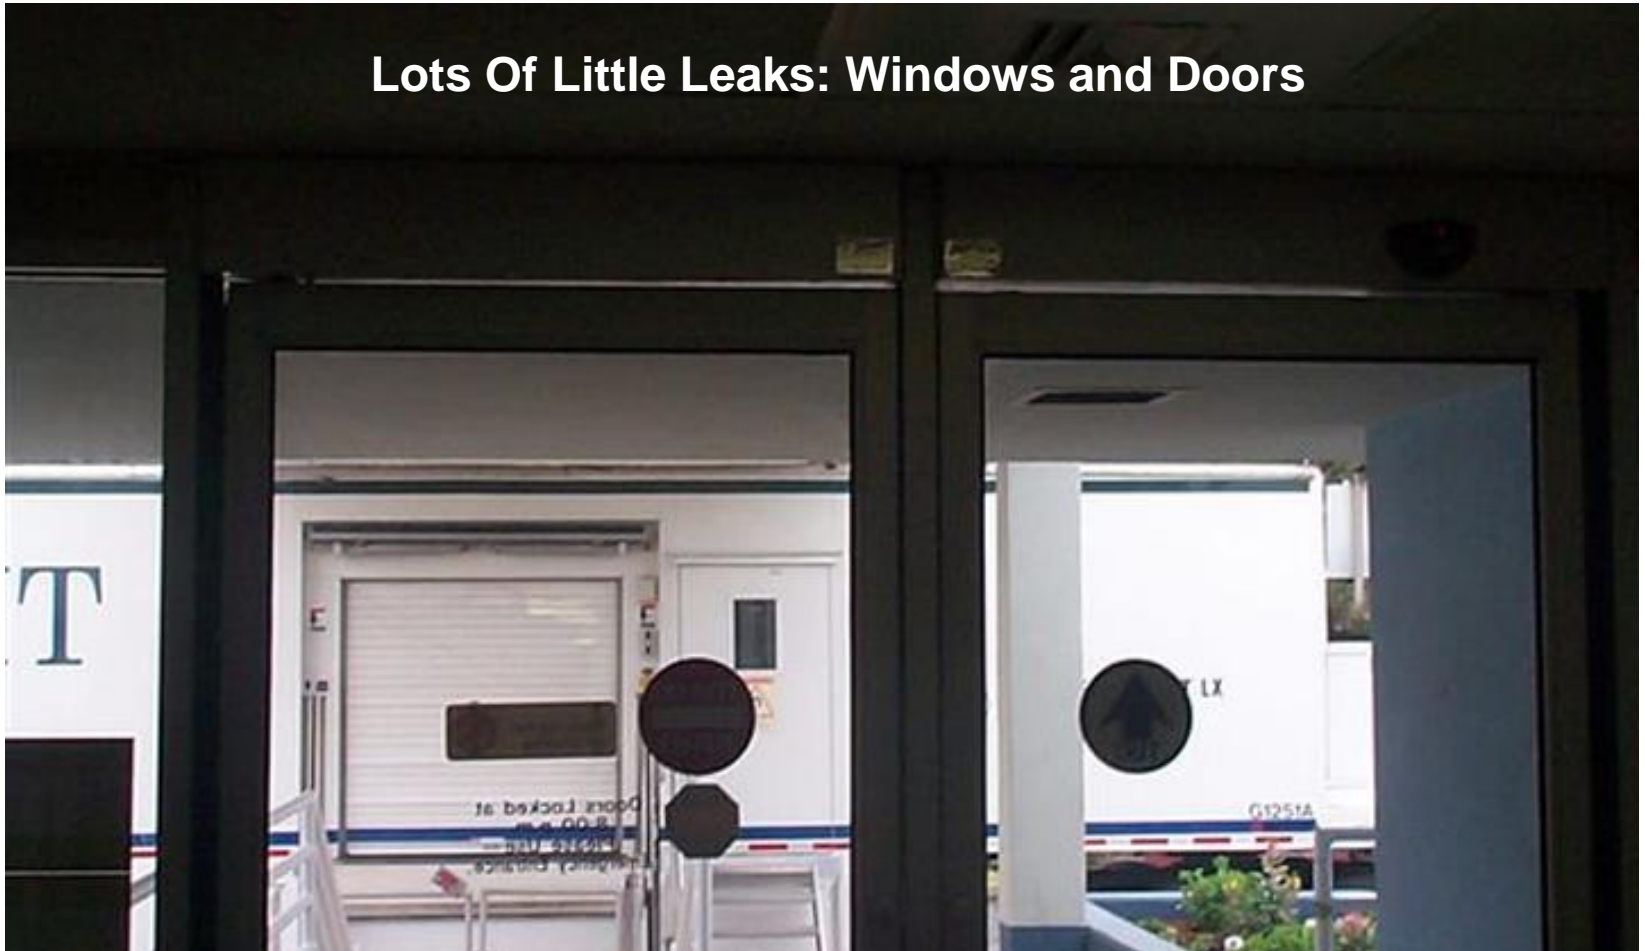
**Lots Of Little Leaks: Windows and Doors**

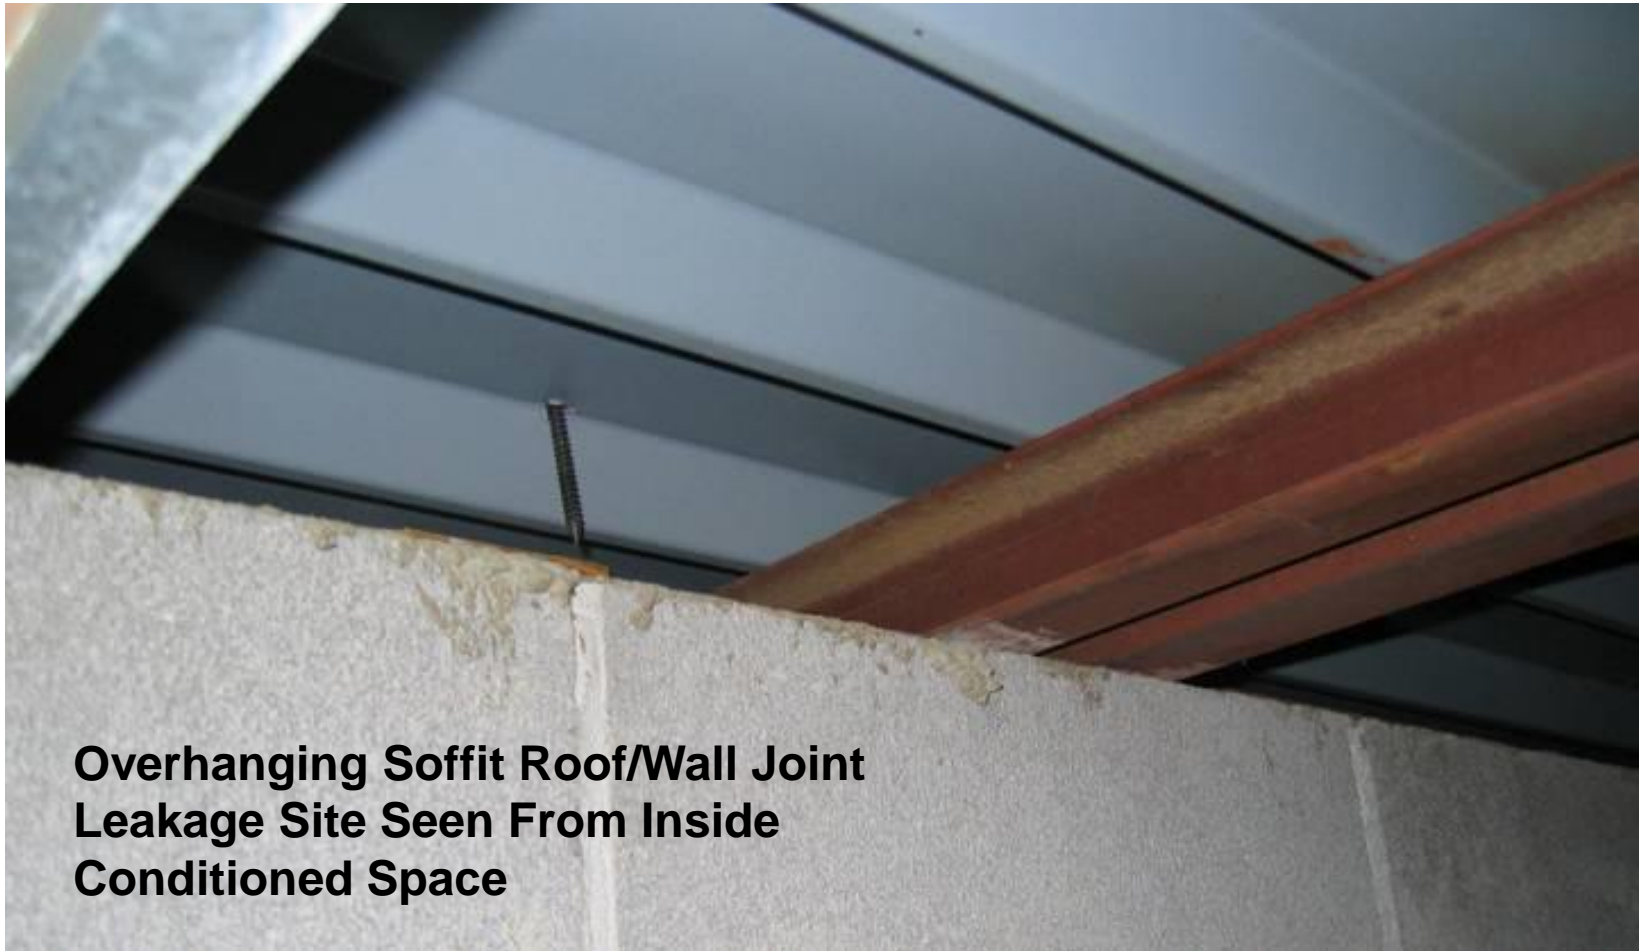
**Overhanging Soffit Roof/Wall Joint  
Leakage Site Seen From Inside  
Conditioned Space**

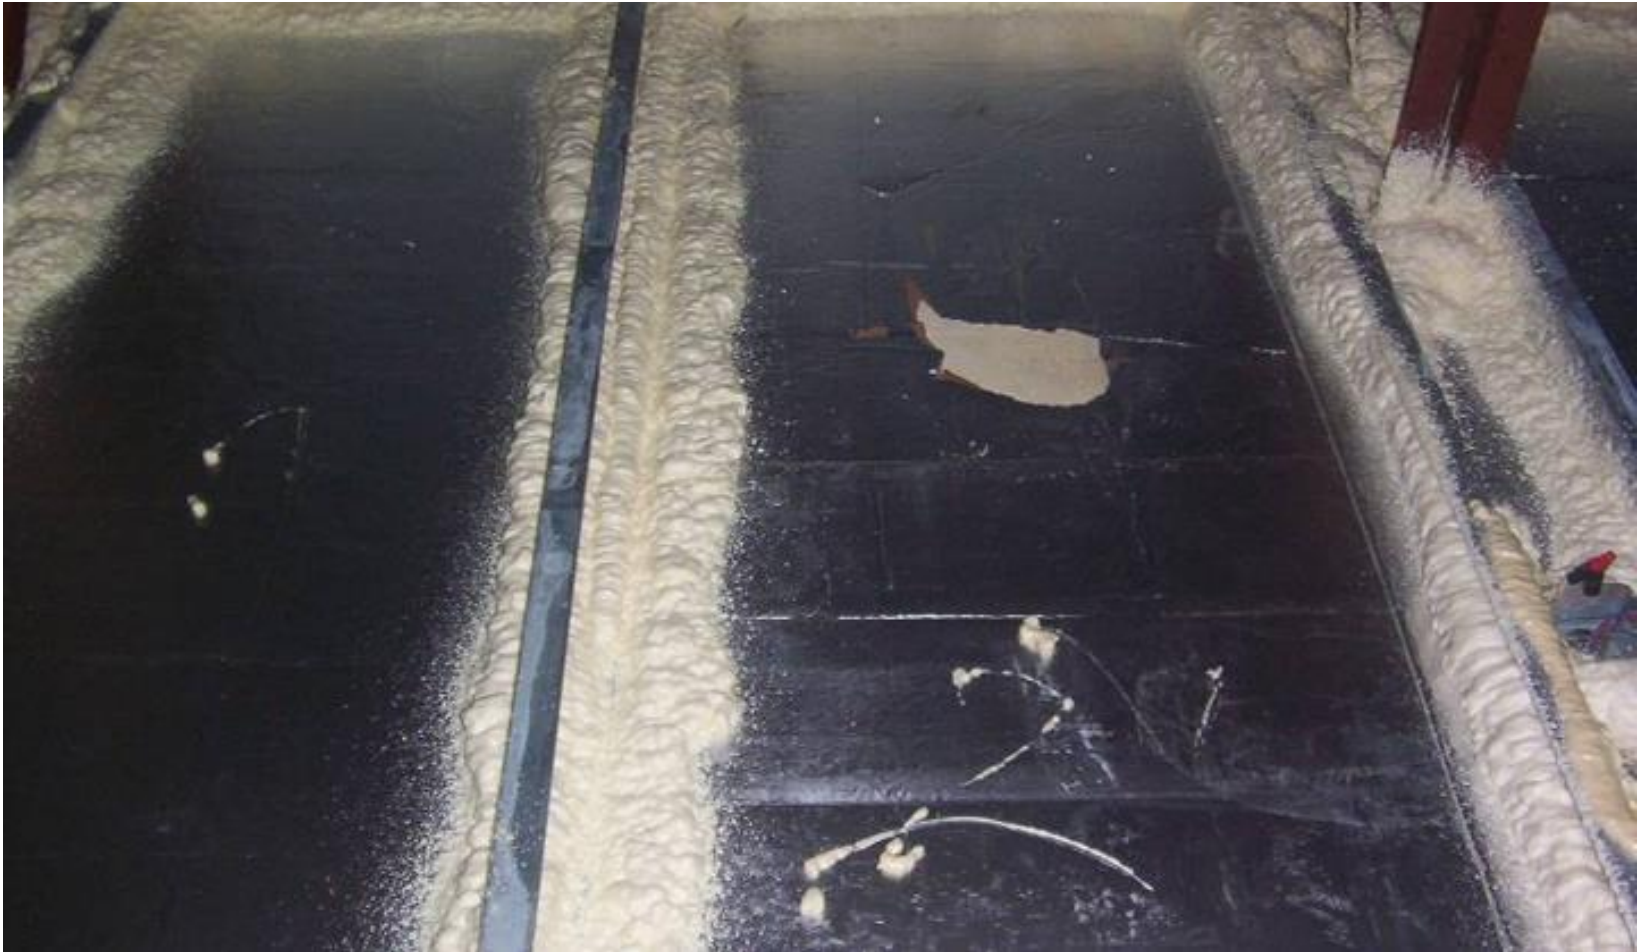
Metal soffit panel seams, sealed with foam sealant
